# Targeted Sewer Inspection Pilot Report

March 12, 2021

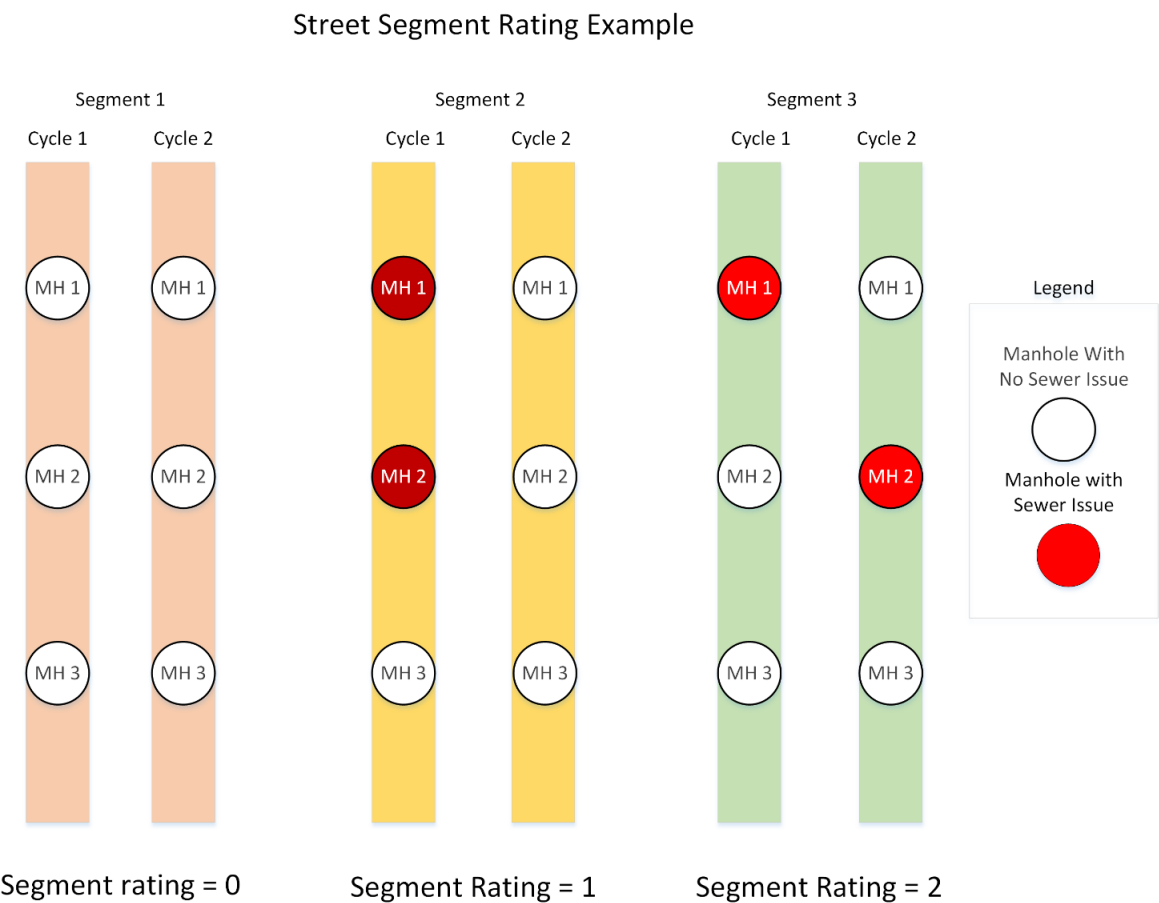
The inspections were aggregated by street segment with each street segment receiving a rating of 0, 1 or 2 based on the following criteria:

- 0- No manhole inspection on the street segment in either the first or second inspection cycle indicated any issues with the sewer, as defined above.
- 1- At least one manhole inspection on the street segment during either the first OR second inspection cycle (but NOT both) indicated an issue with the sewer.
- 2- At least one manhole on the street segment during BOTH the first and second inspection cycle indicated an issue with the sewer.

DEP chose these rating criteria to characterize the frequency of sewer issues found on a particular street segment. Below is a graphic showing an example of this rating system.

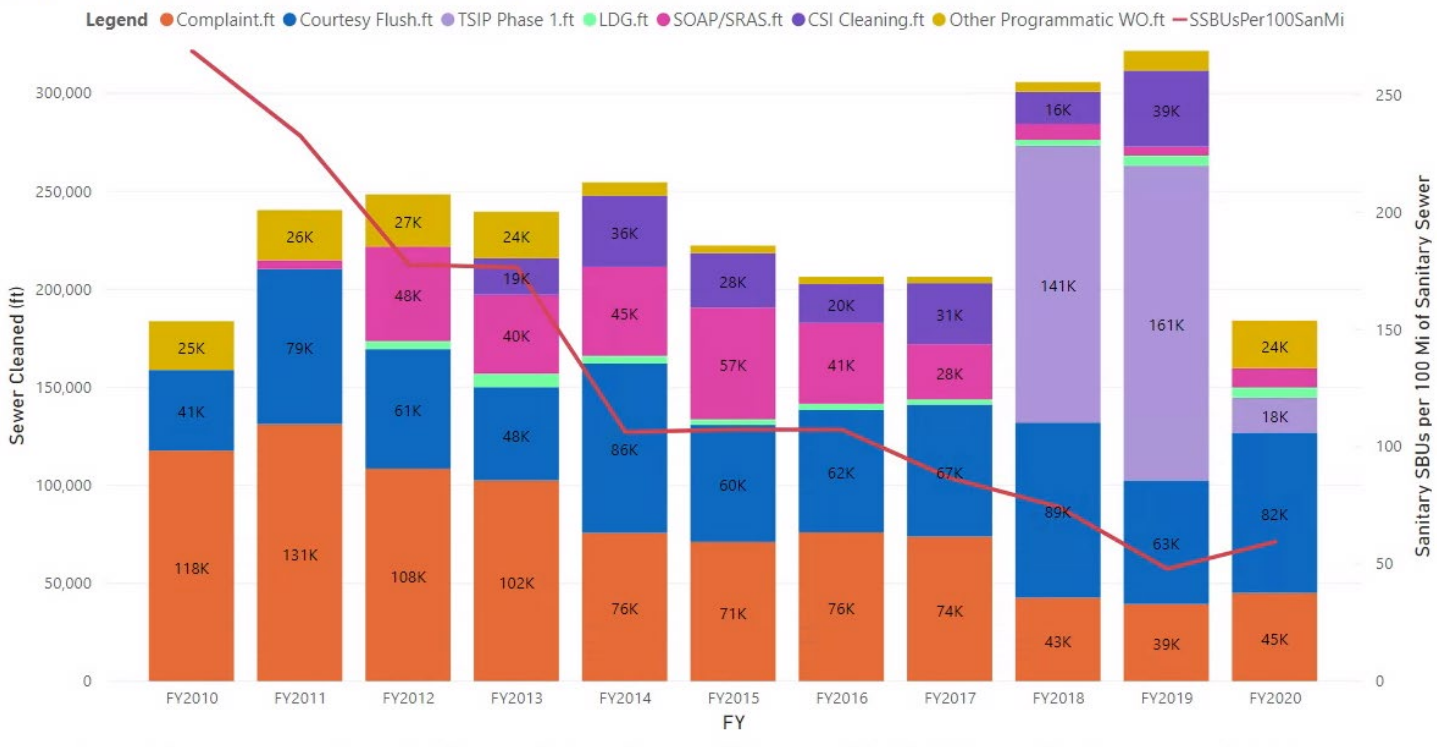
Sewer Length Cleaned vs Sanitary SBU's per 100 Mi of Sanitary Sewer Per FY

In Brooklyn, DEP completed most TSIP Phase 1 work in FY18 and FY19, with ~ 5% completed in FY20.

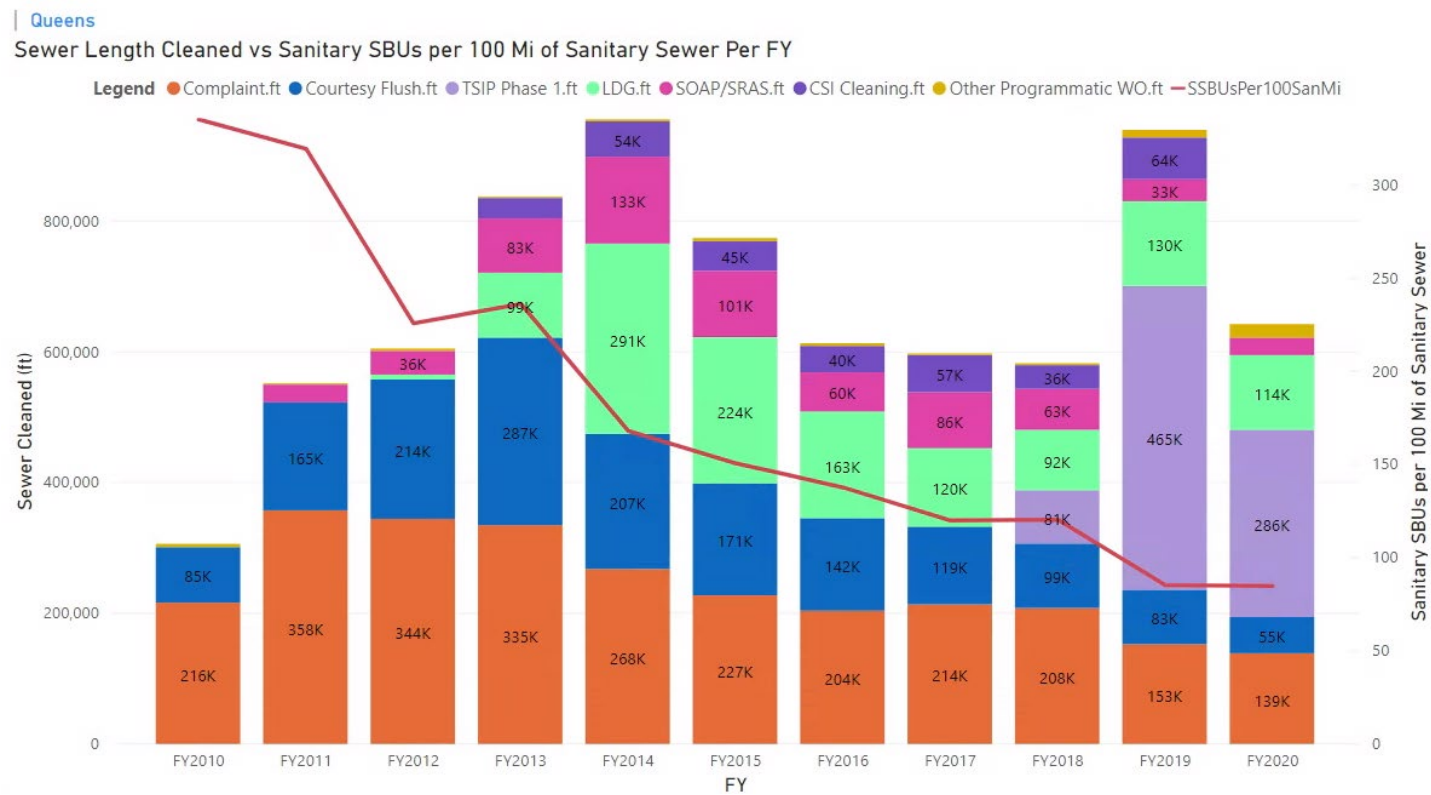
In Queens, most work was completed in FY19 and FY20.

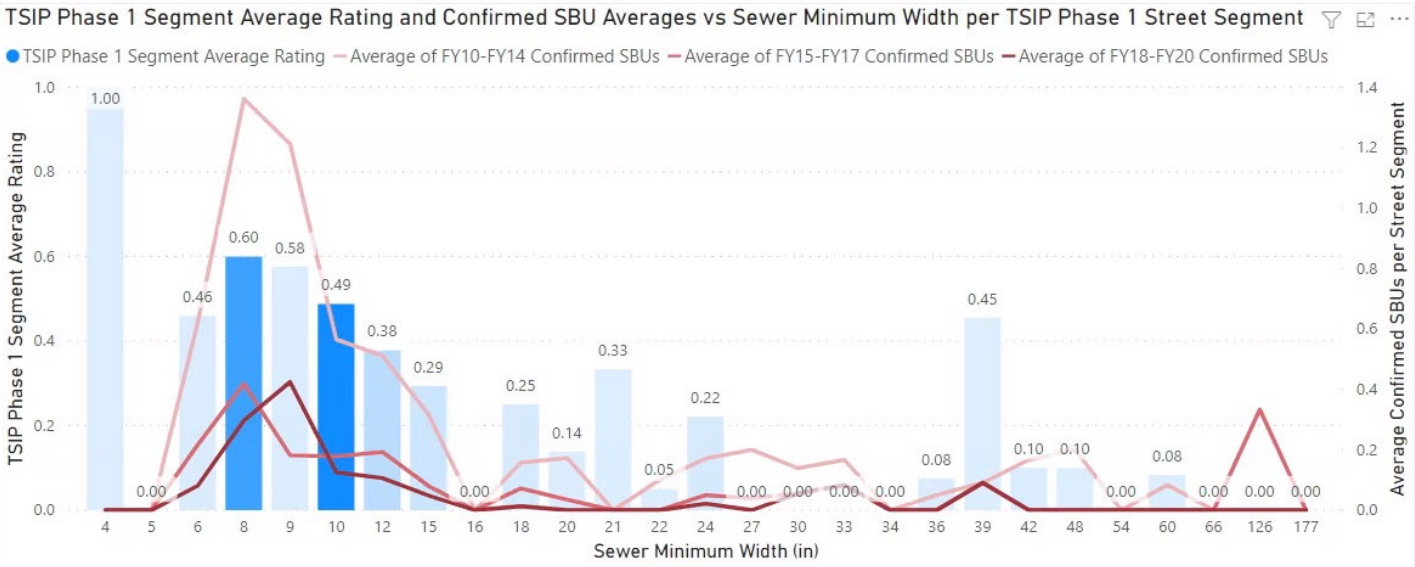
- 1. **Minimum Sewer Width**
  - a. Generally, 8” sewers have higher SBU rates and a higher rate of issues found during TSIP Phase 1 inspections than do 10” and 12” sewers in the TSIP Phase 1 Community Boards. These smaller sewers tend to be older, with 8” sewers across the TSIP Phase 1 Community Boards having an average age of 84 years, 10” and 12” having an average age of 65 years.
  - b. The first chart below shows the average TSIP Phase 1 segment rating for each minimum sewer width overlaid by the average number of confirmed SBUs occurring per street segment for that sewer width for three periods – from FY2010 to FY2014, from FY2015 to FY2017, and from FY2018 to FY2020. The bar transparency indicates the number of street segments, which is also shown in the bottom chart.
  - c. One segment was missing sewer width data.

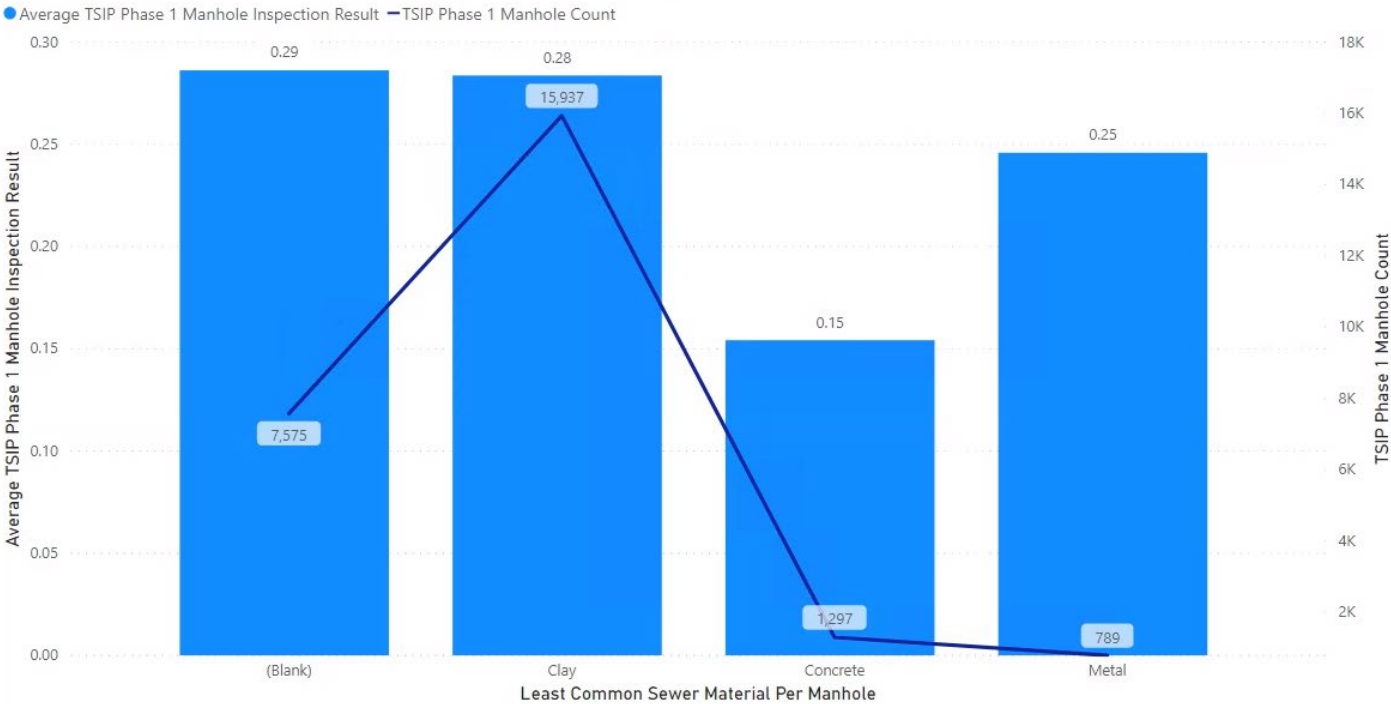
Average TSIP Phase 1 Manhole Inspection Result and Manhole Count by Least Common Sewer Material Per Manhole

- a. DEP evaluated this variable per manhole, not per street segment, as there were too many material combinations to assess when evaluating by street segment.
- b. 7,750 manholes (29%) did not have a sewer material associated with any intersecting sewers. For each manhole with known sewer materials, the most common non-clay sewer material was determined. If a manhole intersected only clay sewers, the inspection would be assigned “clay.” If a manhole intersected a clay sewer and a sewer made of another material, the manhole would be assigned the non-clay material.
- c. Clay sewers had the worst average inspection result followed by metal sewers and then concrete sewers.

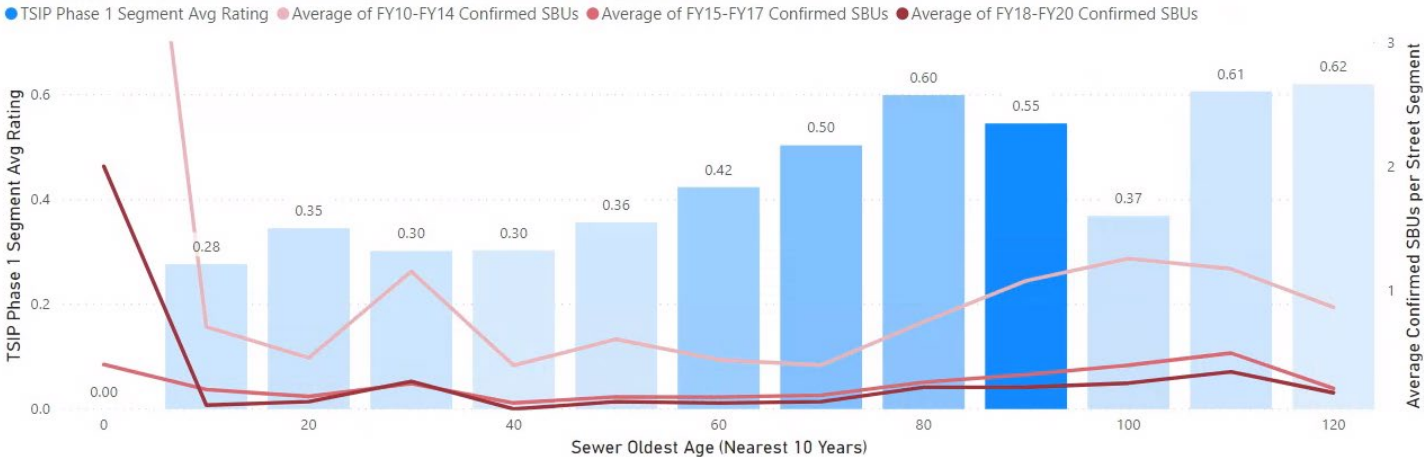
TSIP Phase 1 Segment Average Rating and Confirmed SBU Averages vs Maximum Sewer Age per TSIP Phase 1 Street Segment

DEP found higher TSIP Phase 1 segment ratings and a small increase in confirmed SBU rates with increasing sewer age per street segment. This metric corresponds roughly to sewer size, as smaller sewers tend to be older as well. Below are two charts illustrating this relationship.

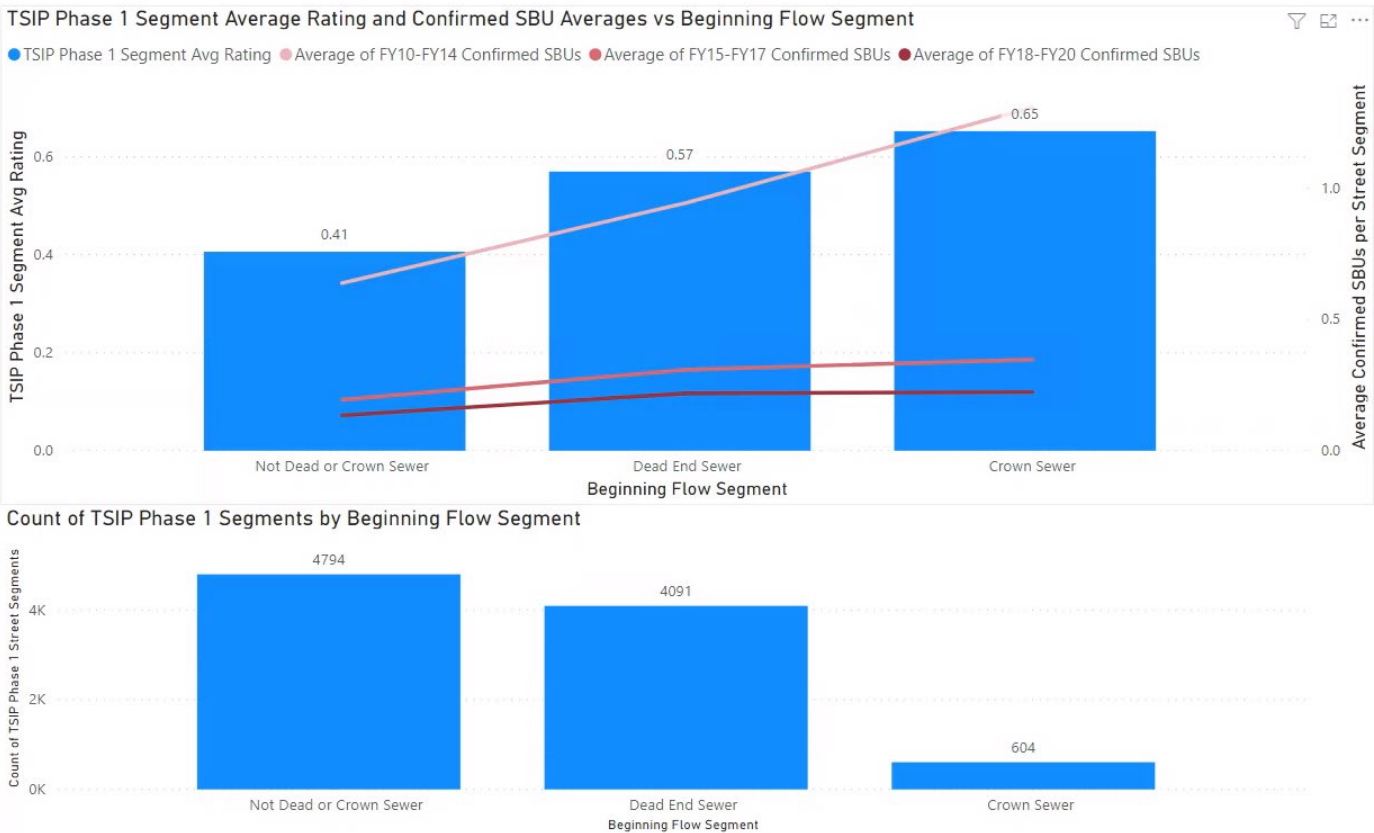
Dead End Sewer and Crown Sewer street segments are those where sewer flow starts, i.e., street segments containing a manhole with an outlet pipe(s) but no inlet pipe. DEP has observed during Phase 1 that these segments tend to have lower flow than pass-through segments (segments where all manholes have an inlet pipe and an outlet pipe) and had higher rates of SBUs and lower TSIP Phase 1 inspection ratings. Crown segments tend to have lower TSIP Phase 1 segment ratings and more SBUs than dead end segments.

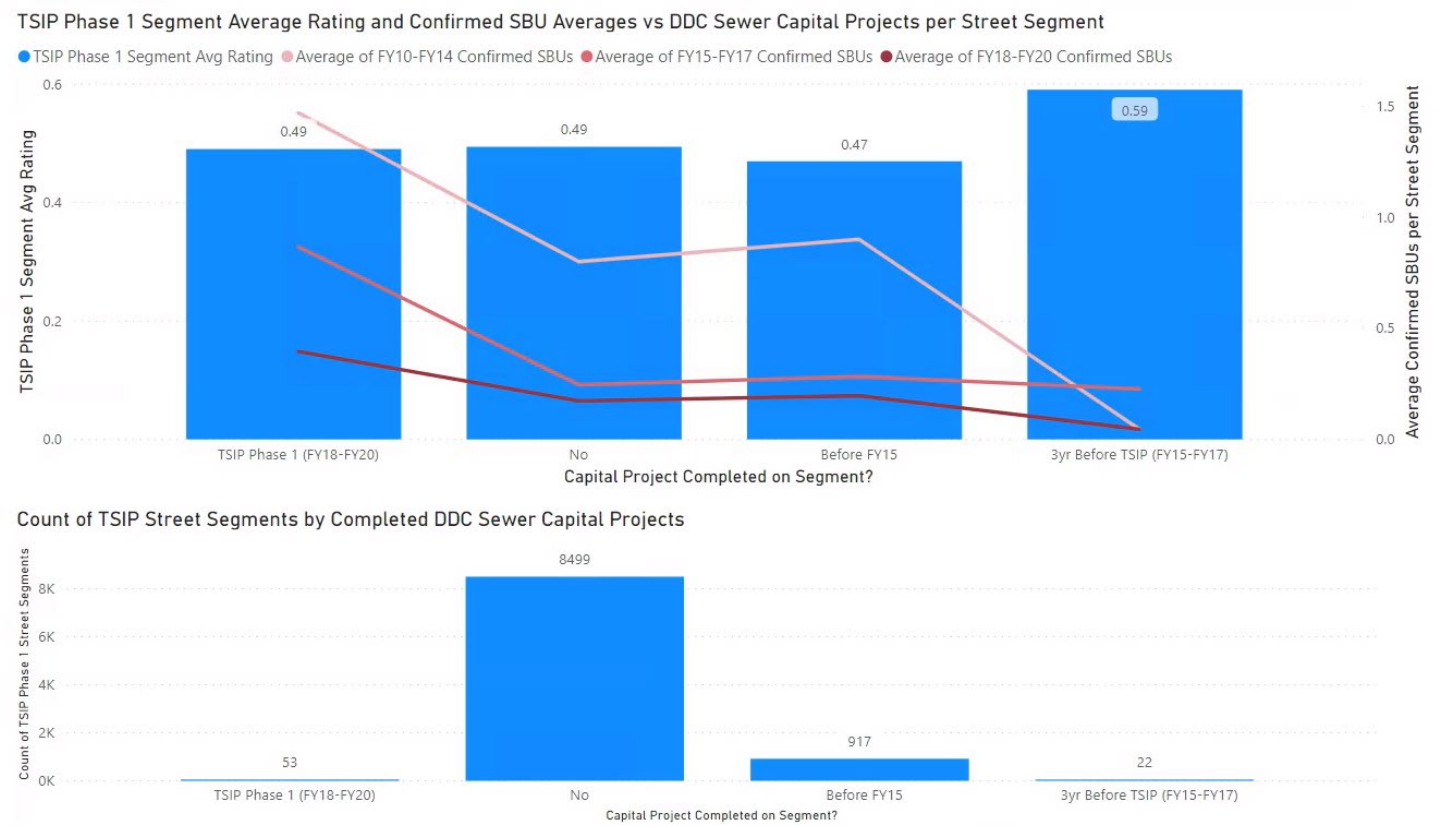
899 TSIP Phase 1 segments (7%) had a NYCDDC (Department of Design and Construction) or NYCEDC (Economic Development Corporation) sewer capital project completed since 1993. For those street segments with capital projects completed most recently (but before FY15), both the average TSIP segment rating and average confirmed SBUs was very similar to those segments that did not have DDC capital projects completed in this period. The number of segments with completed projects 3 years before TSIP Phase 1 and the number during TSIP Phase 1 were too small to draw conclusions from.

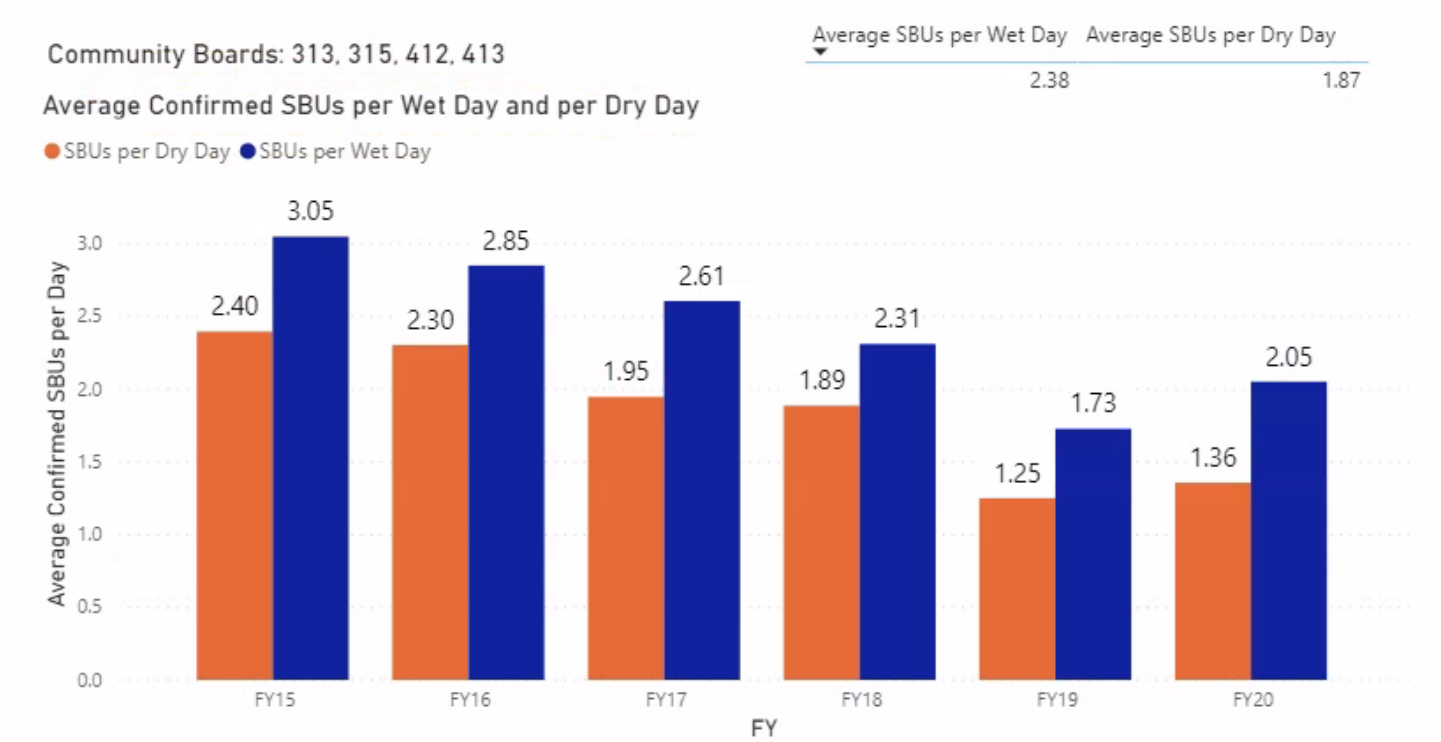
Confirmed SBUs in the TSIP Phase 1 Community Boards tend to occur more on wet days than on dry days. The average from FY15 to FY20 is 2.4 SBUs per wet day, compared to 1.9 SBUs per dry day in these Community Boards.
